Inflow and Infiltration Study

Private Property Evaluation

City of Chanhassen, Minnesota

SEH Project No. CHANH 150965

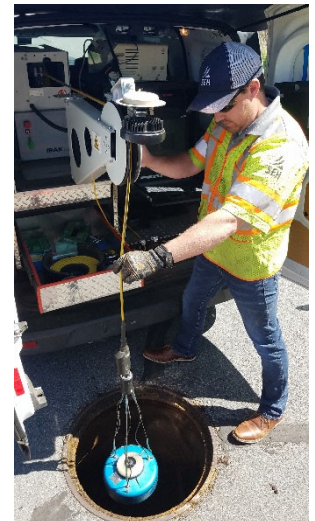
During installation of the flow meter equipment, a number of sanitary manholes were found to be leaking or have evidence of leaking through the discovery of mineral deposits on wall or bench sections of the structure. As part of our investigation, on October 1, 2019, eighteen (18) manholes were inspected using a manhole inspection camera manufactured by IBAK which provides a 360 degree scanned image of the interior of the structure. An illustration of this process has been included which identifies the equipment used to perform the manhole inspections completed under this investigation. The data obtained during the manhole inspection investigation has been included in Appendix B.

Typical IBAK Camera Manhole Inspection

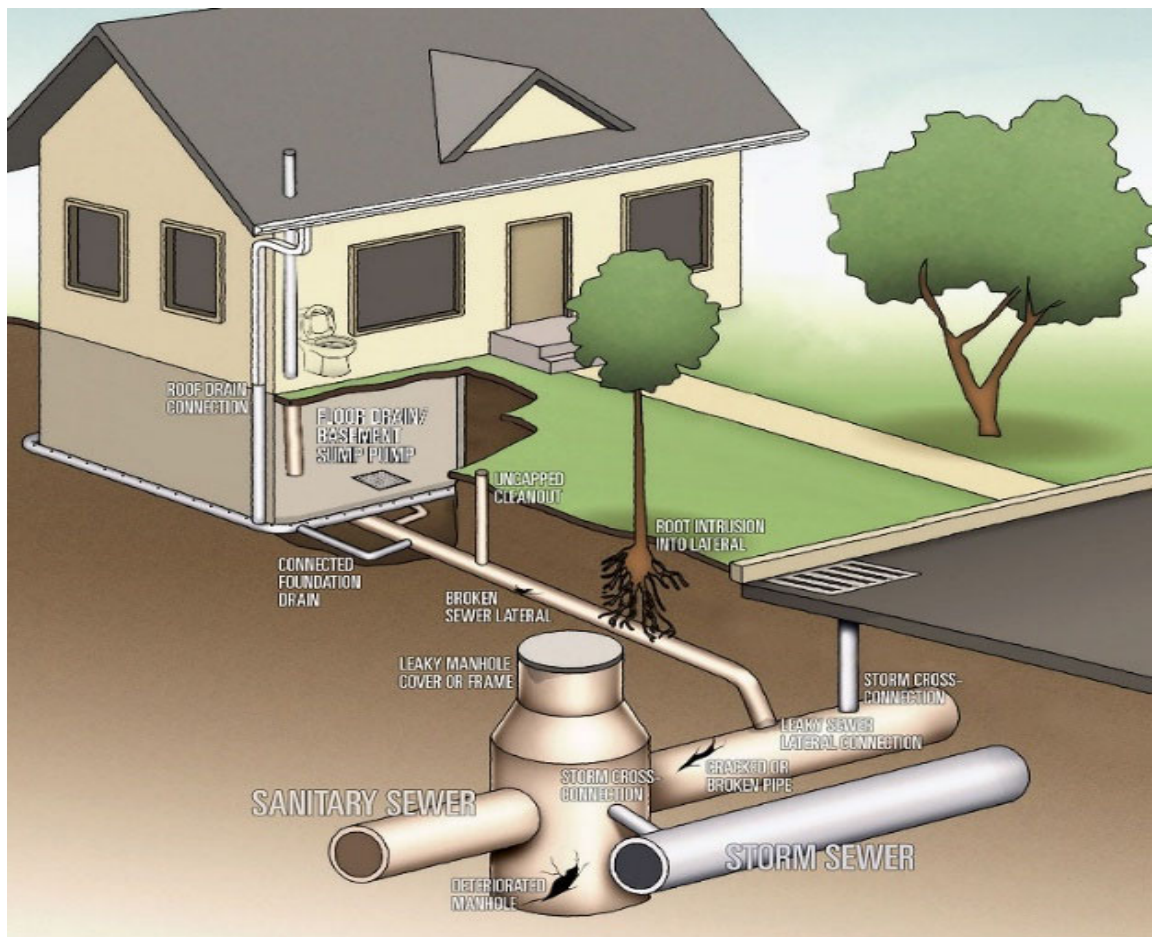
Private property I/I sources can include improper sump pump connections, foundation drain connections, drainage to floor drains, roof leader downspouts, stairwell or area drains connected to the sanitary sewer lateral, damaged cleanouts subject to surface drainage and/or damaged sewer service laterals. An illustration identifying many of these possible I/I sources from residential and commercial private property is presented below.

Typical Private Property I/I Sources

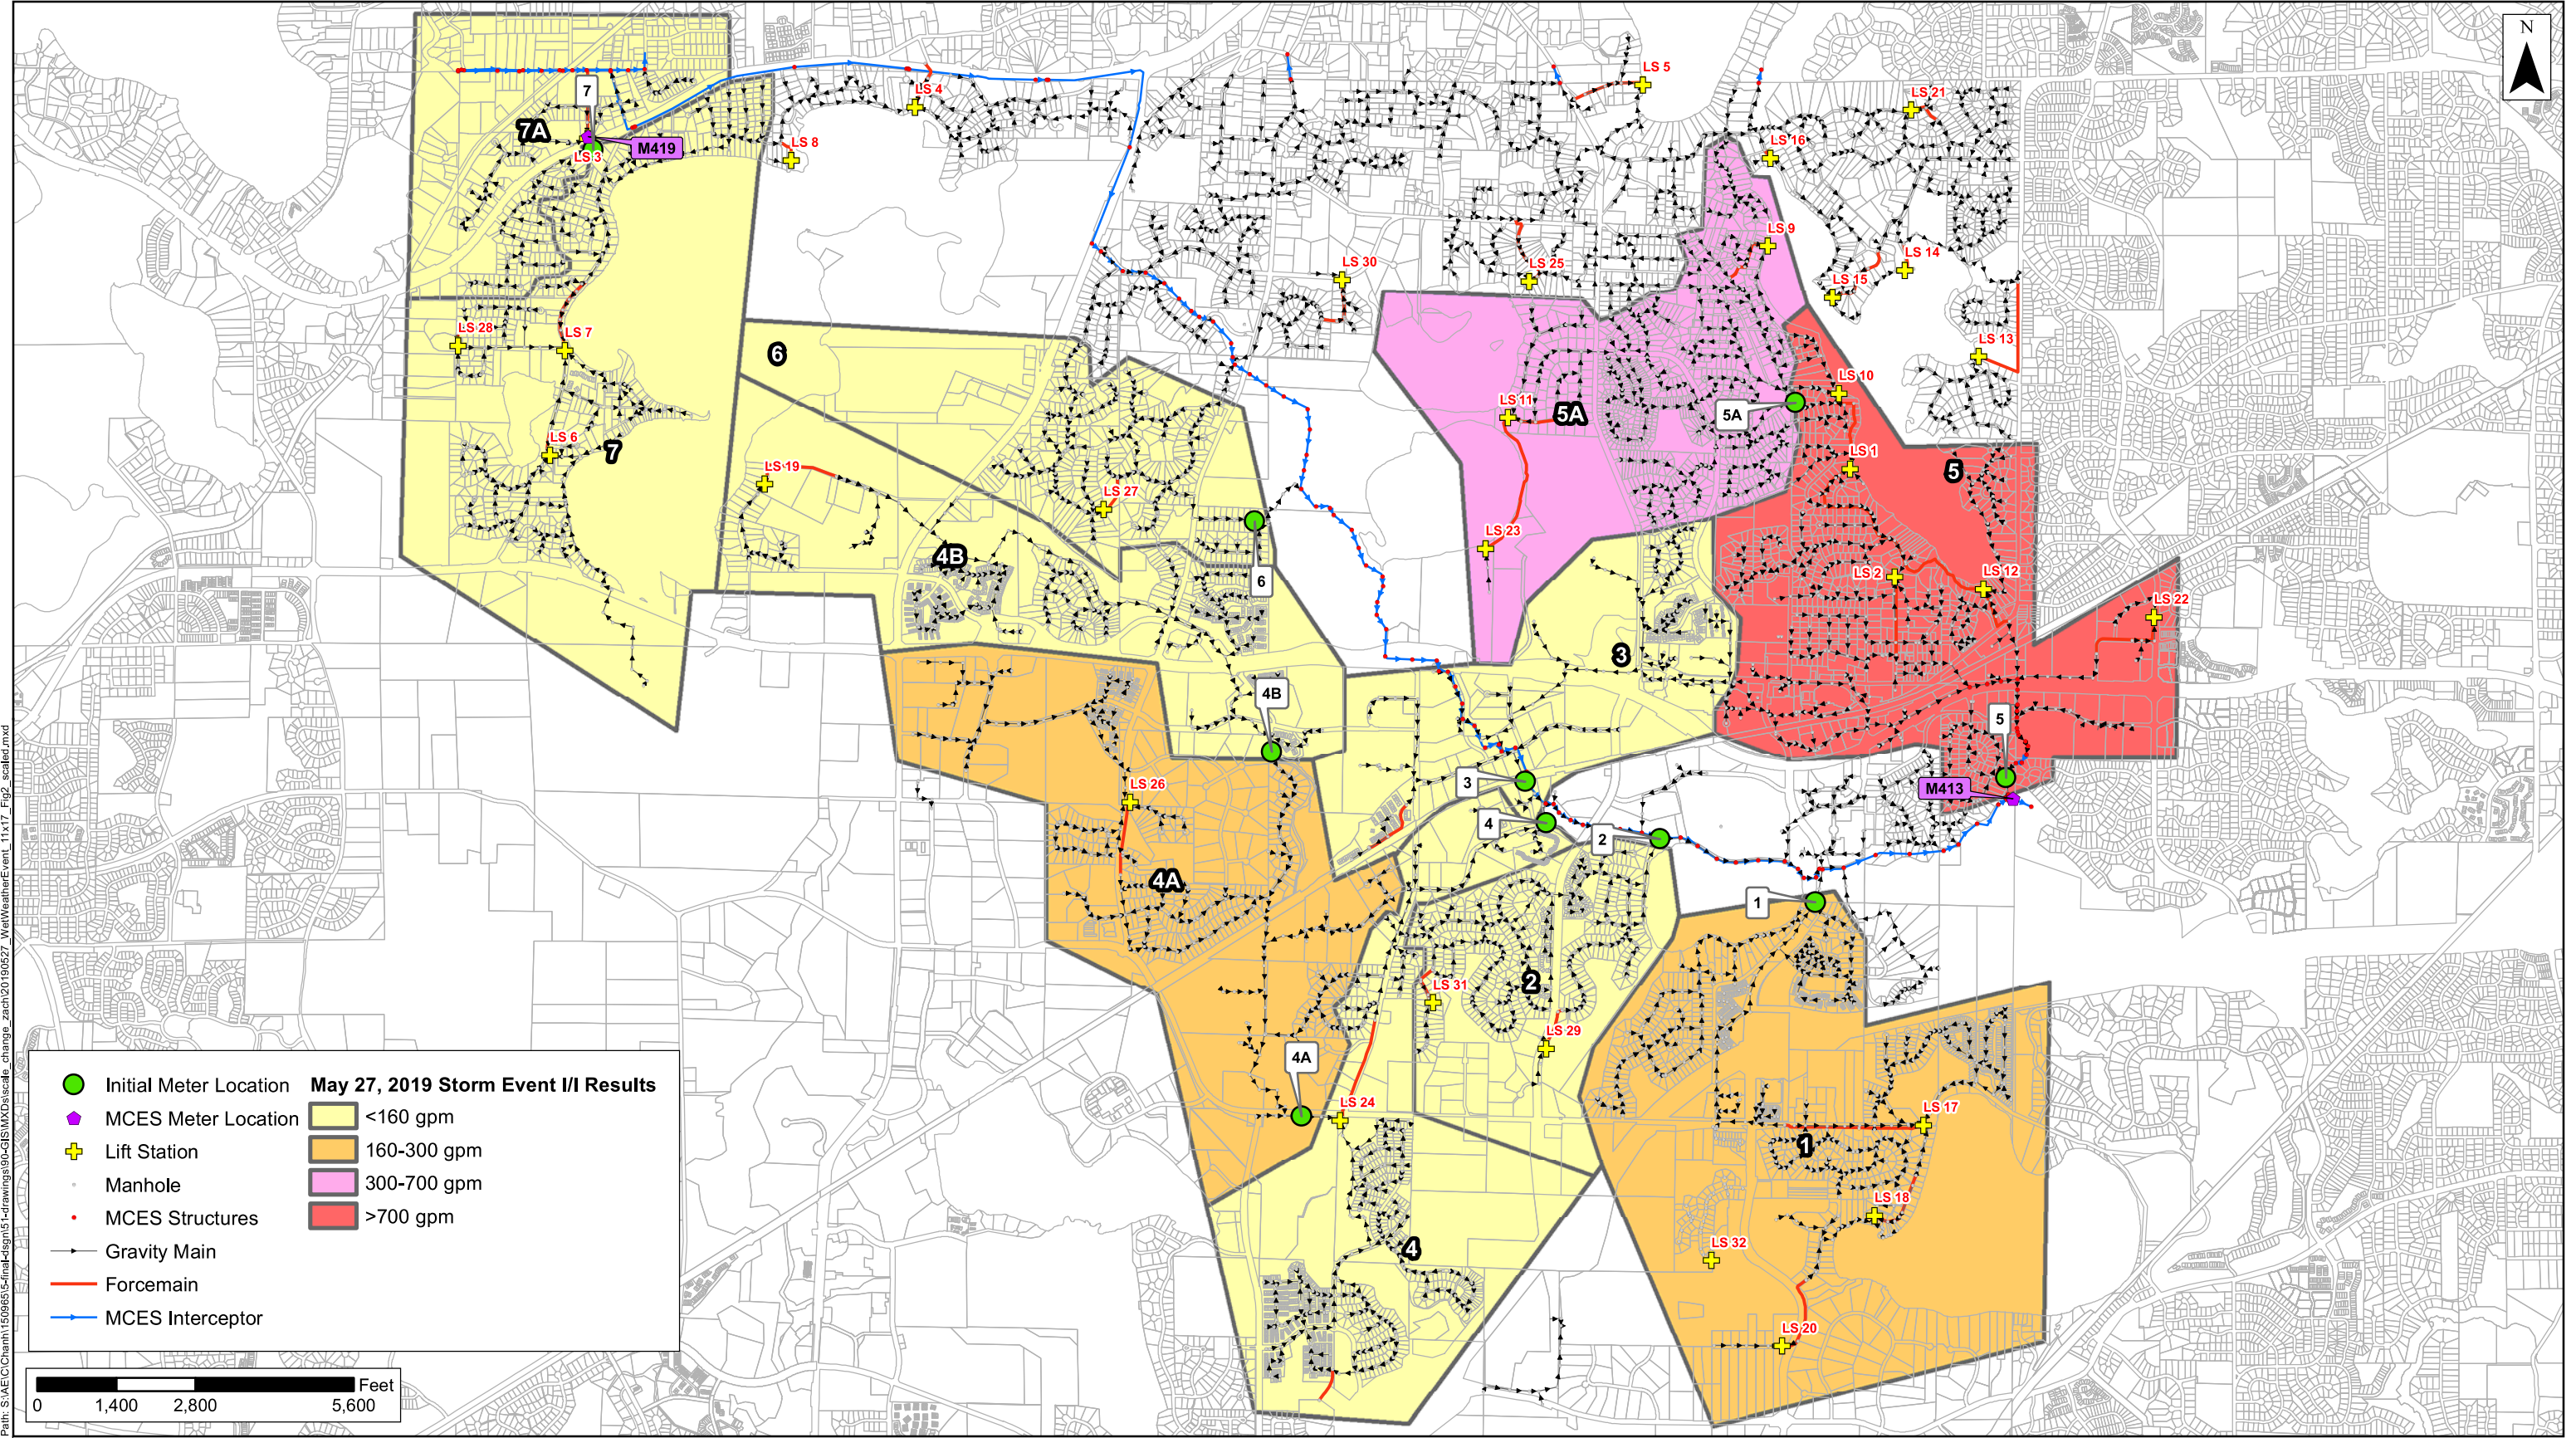
Figure
2

Three sewer districts (5, 5A and 7) produced the highest peak rates during the May 27, 2019 wet weather event and contributed the largest amount of I/I based on peak hour rates. In order to further investigate wastewater flow conditions in the Sewer Districts 5 and 5A, eight flow meters were relocated the last six weeks of the flow monitoring period to capture additional flow data. The result of the additional flow monitoring isolated the highest peak I/I responses during wet weather conditions in Sewer Districts 5-2, 5-3, 5-4, 5A-2 and 5A-3.

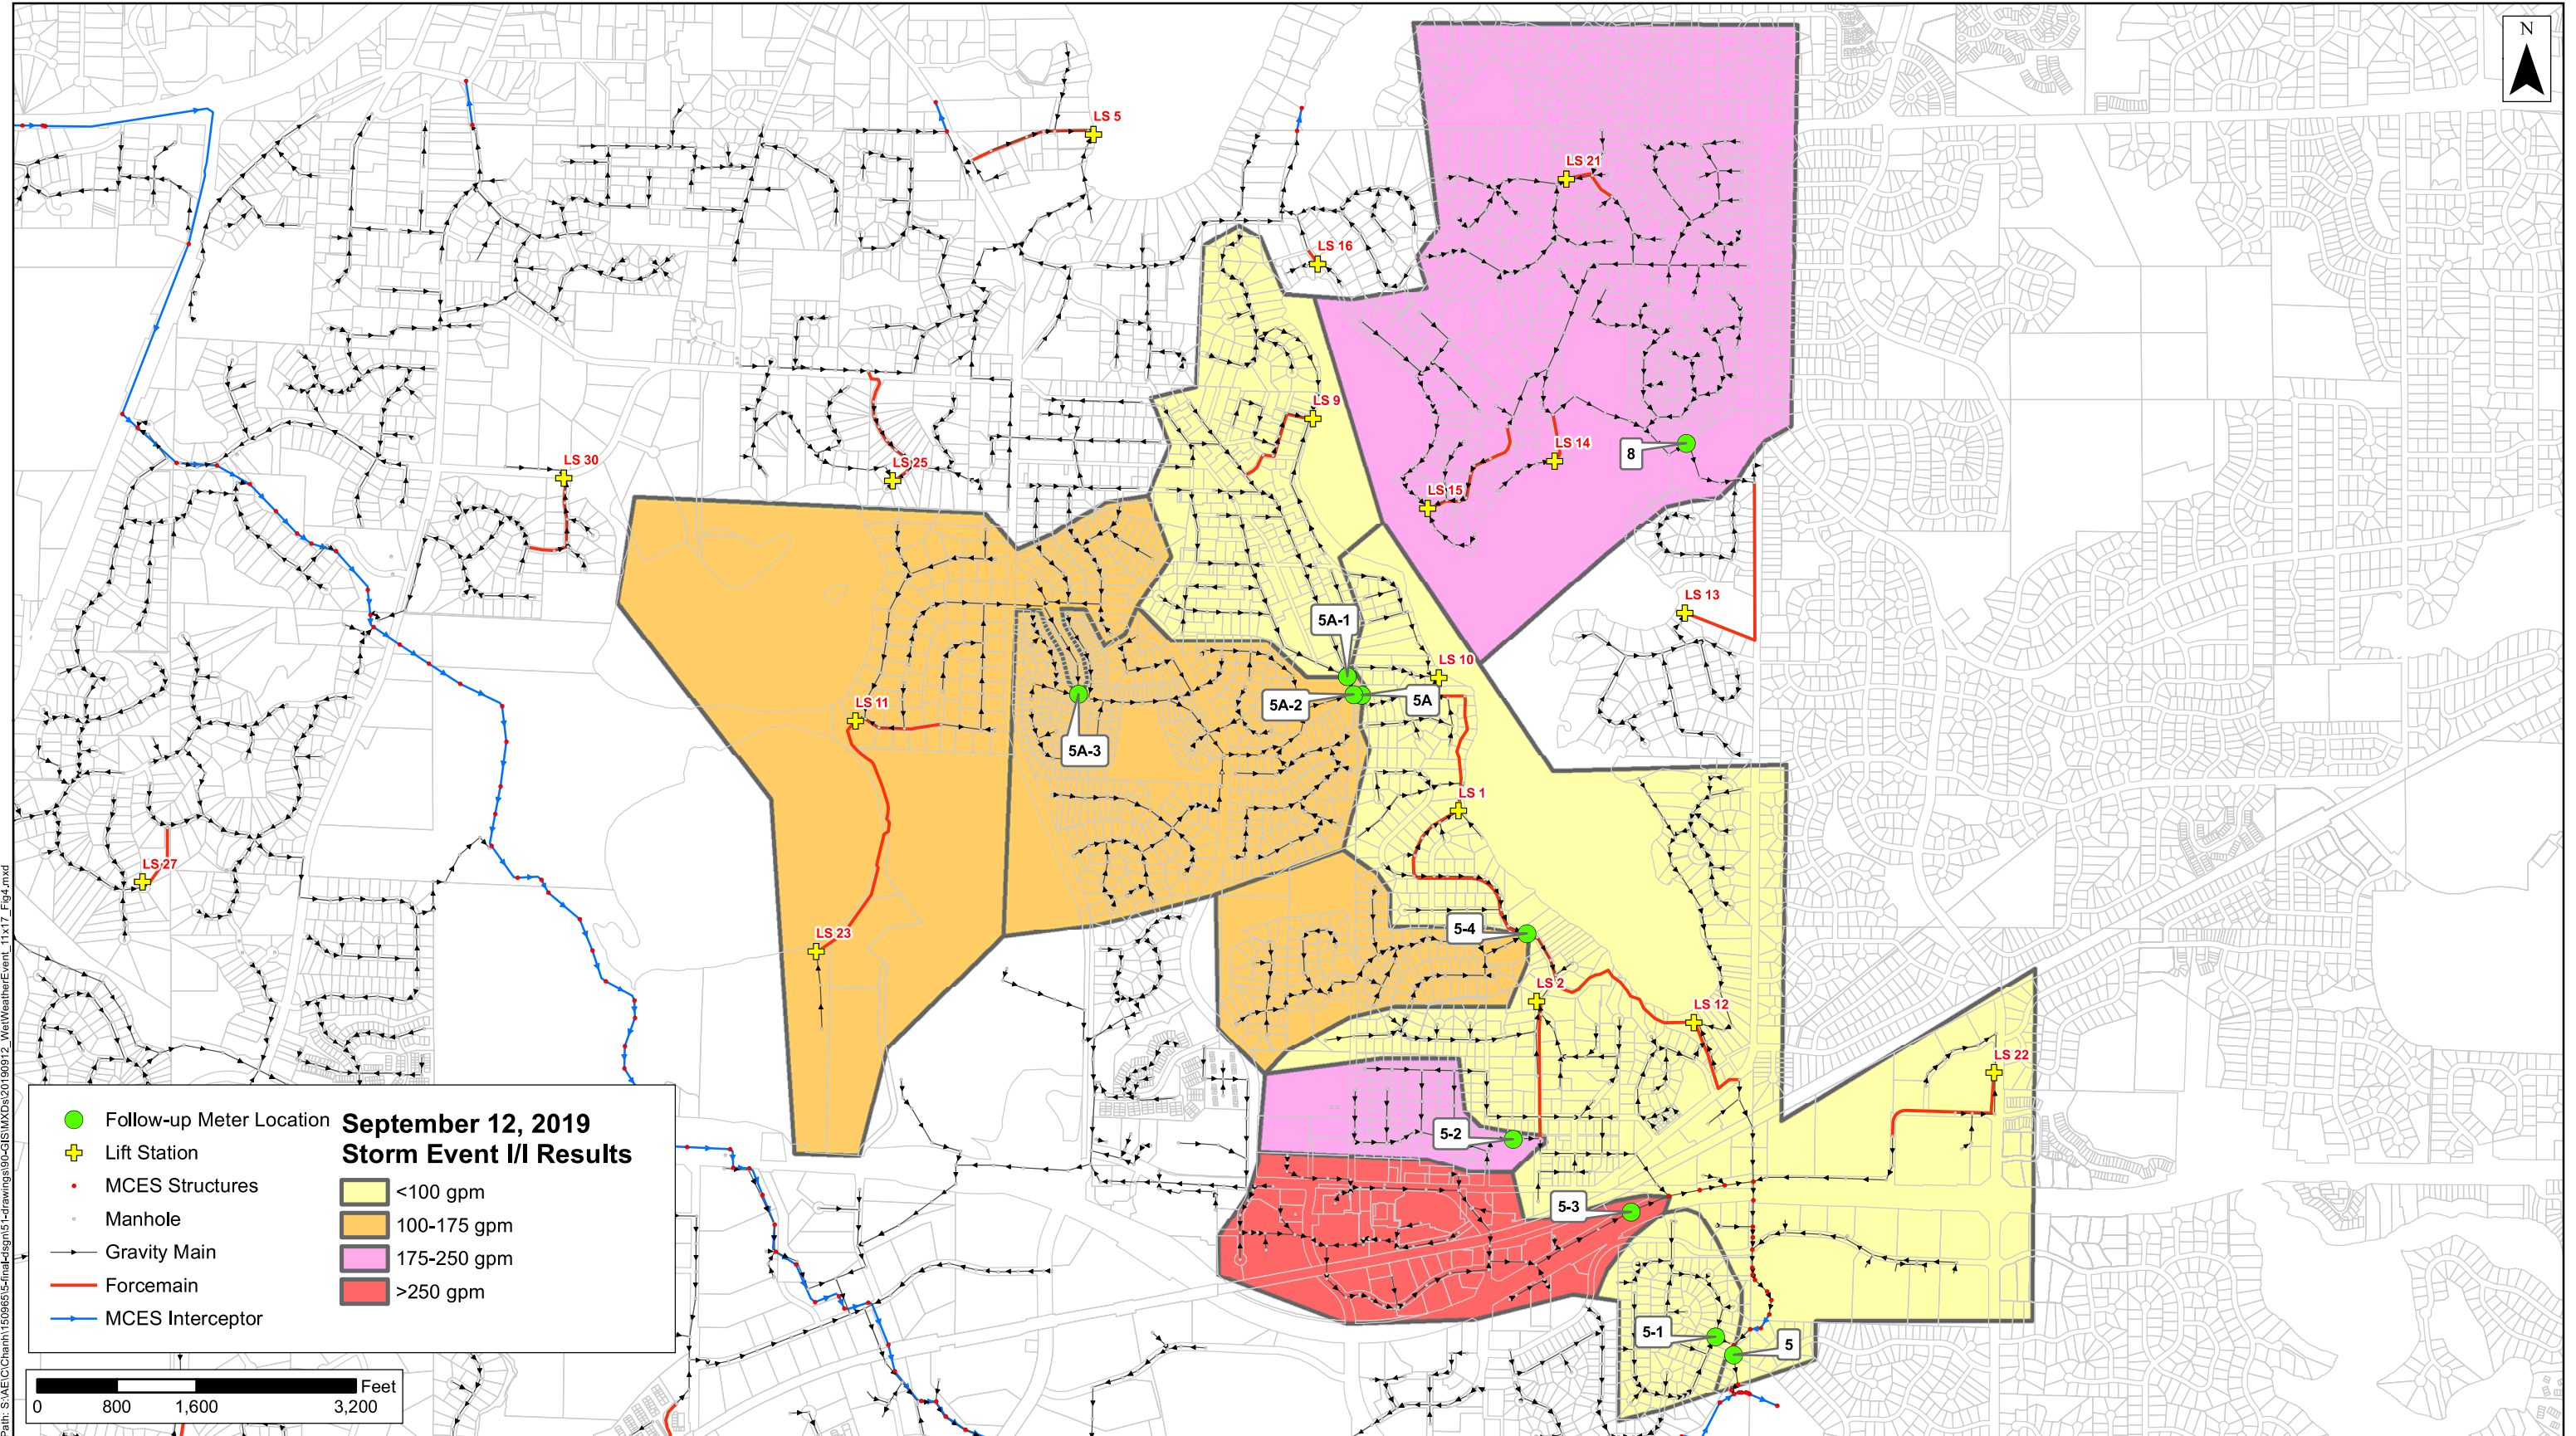
Figure 4 – September 12, 2019 Wet Weather Event
